# Deformation and Damage of Railway Crossing studied by X-ray Tomography and other methods

## Intelligent Quality Assessment of Railway Switches and Crossings

WP-4 : Metallurgical Characterization

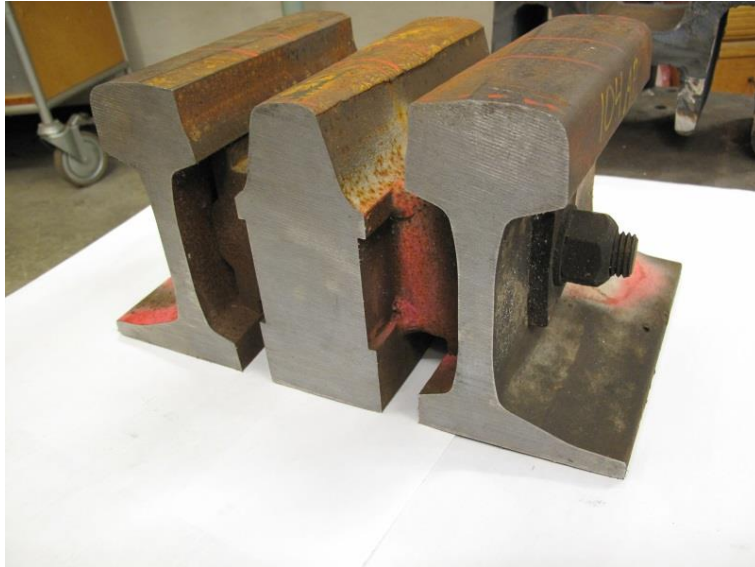
Vestfyn

Pearlitic Railway Crossing

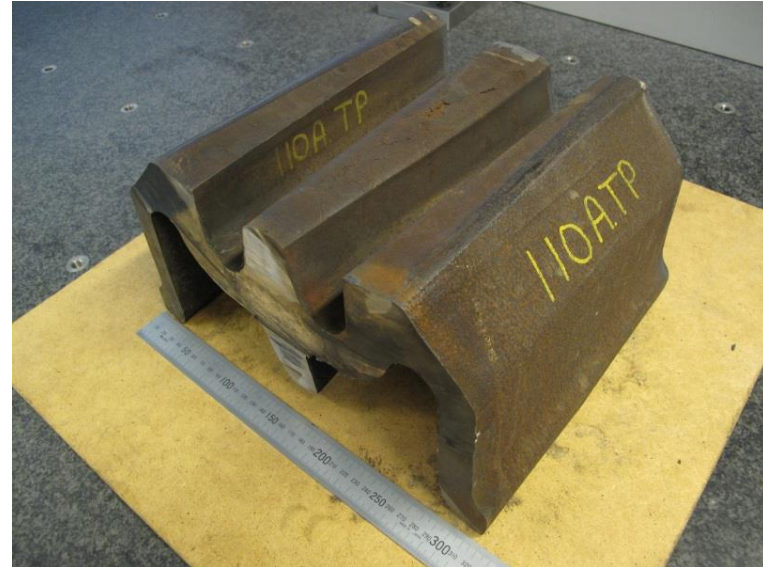
Tommerup

Manganese Railway Crossing

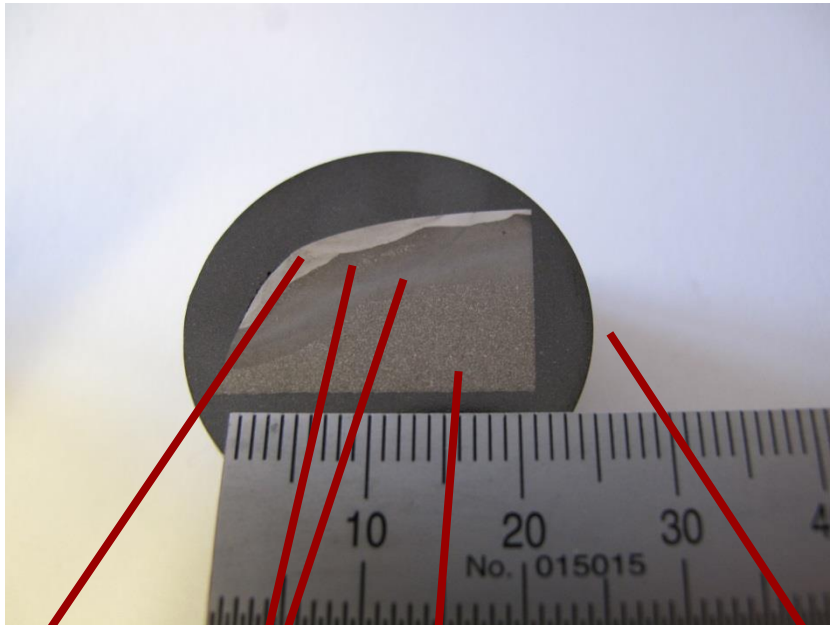
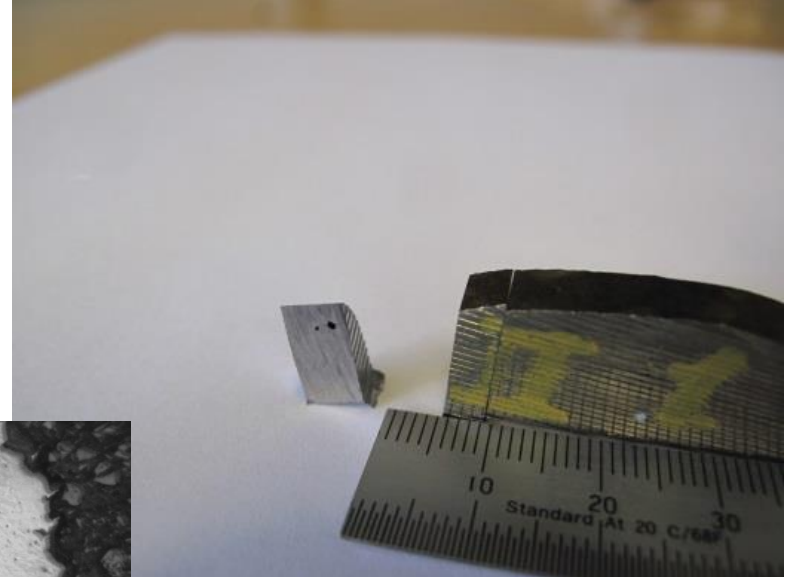
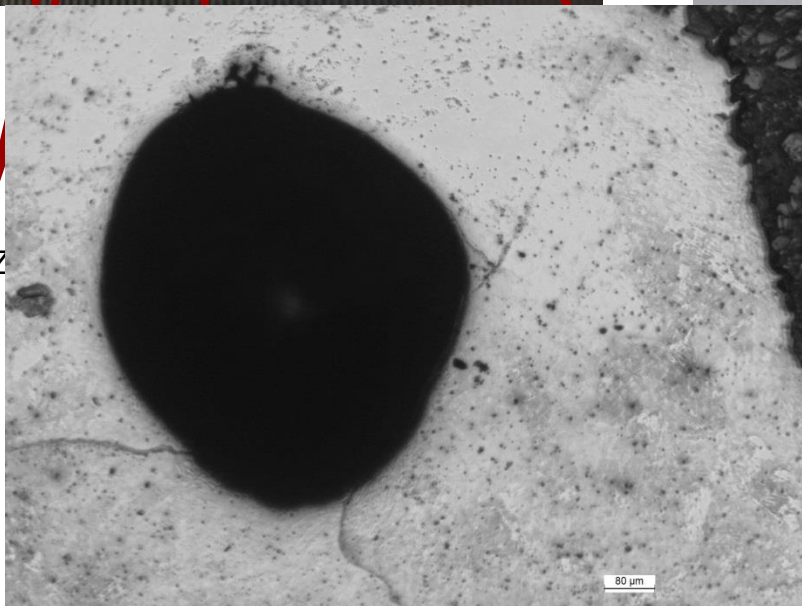
# Defects in Nose :

Weld  
Layer

HAZ

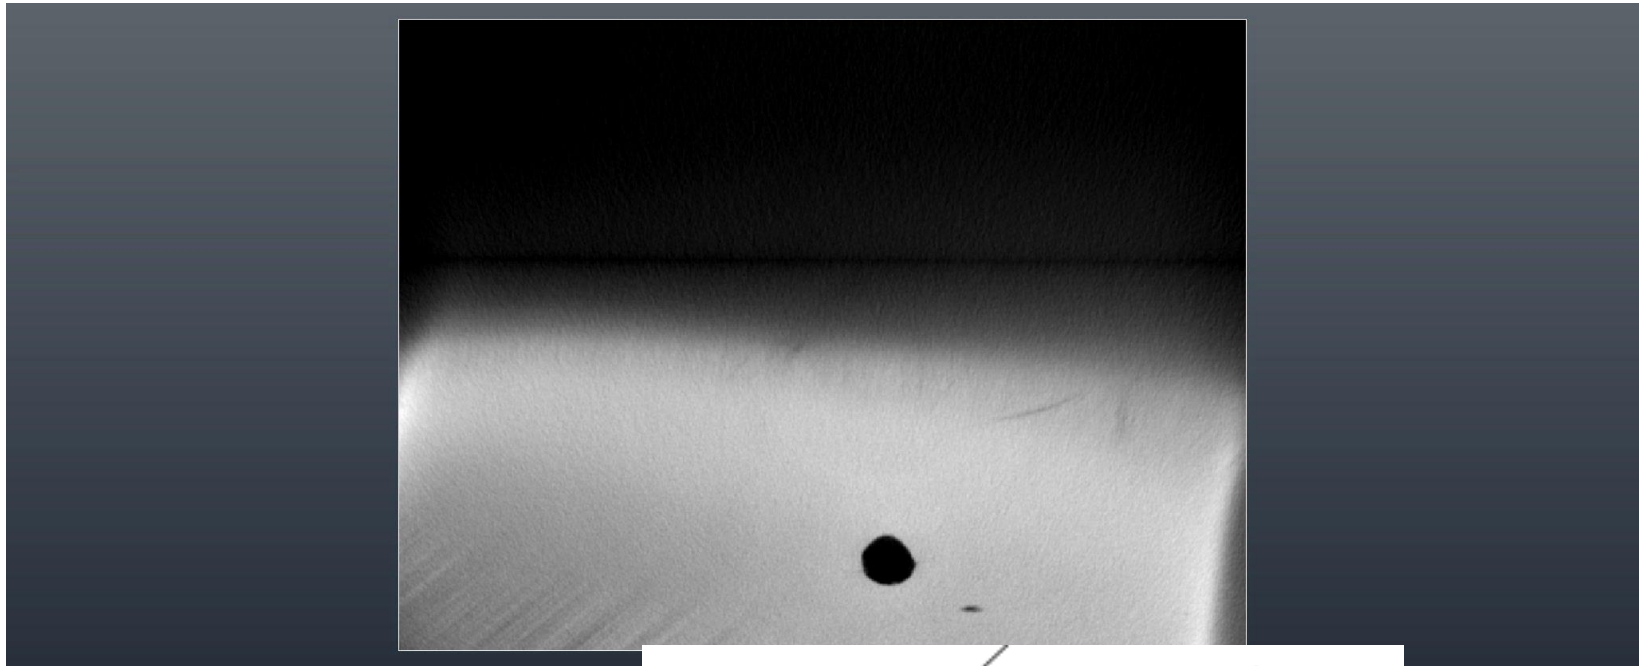
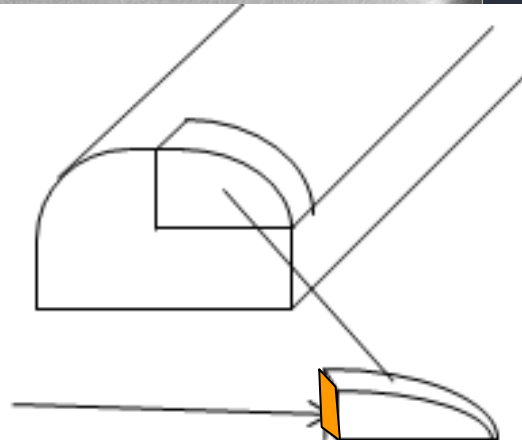
# X-Ray CT Scanning of Nose

4.6 mm

AP104 II Nose  
rail section

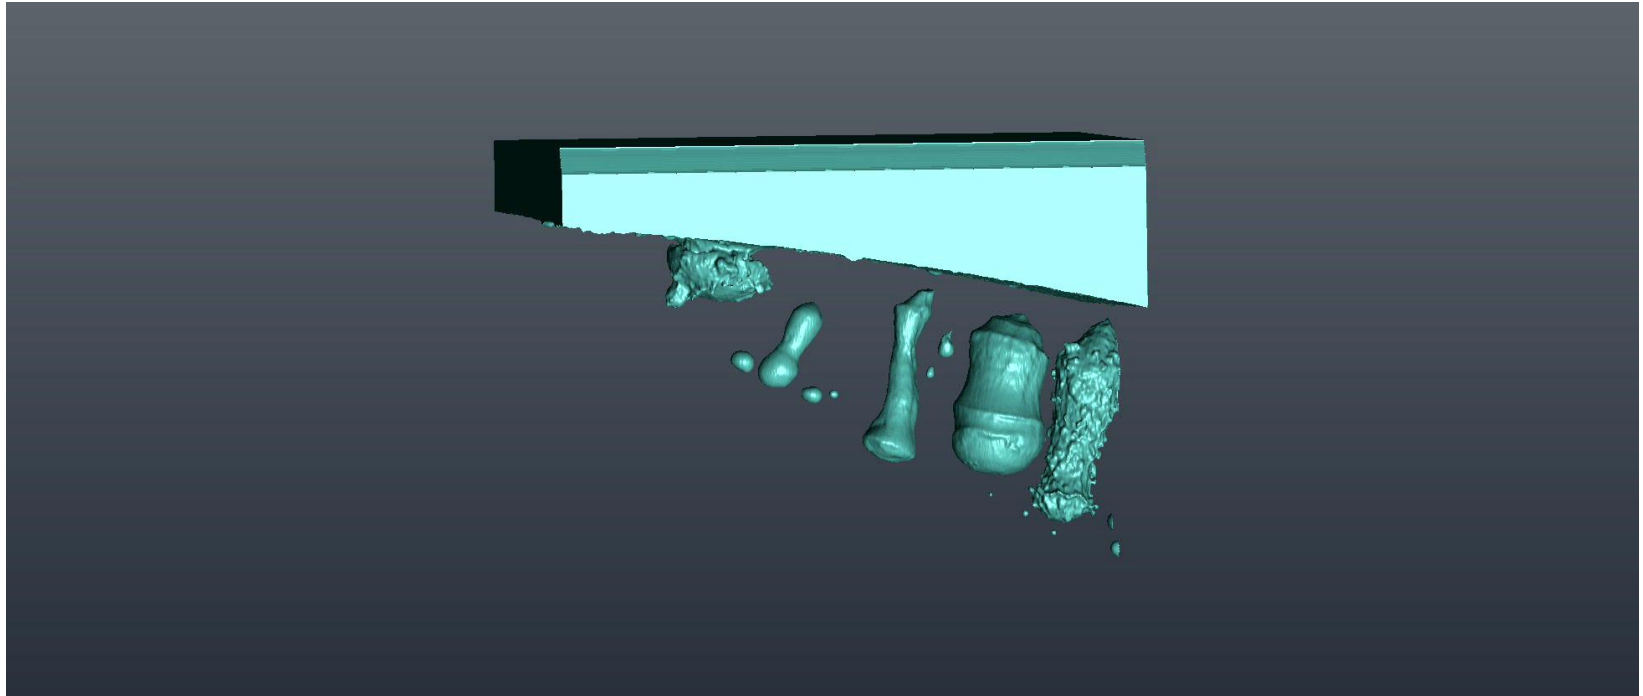
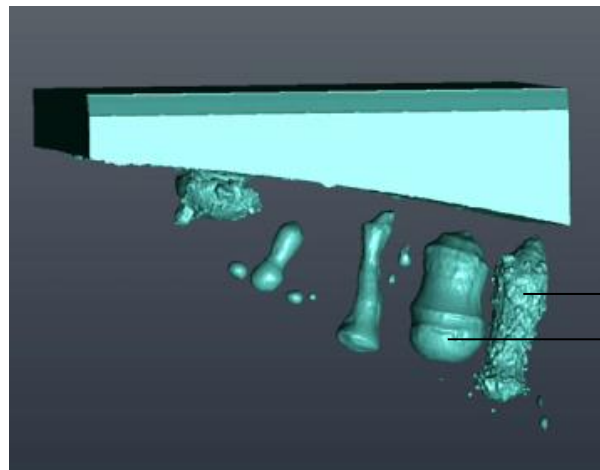
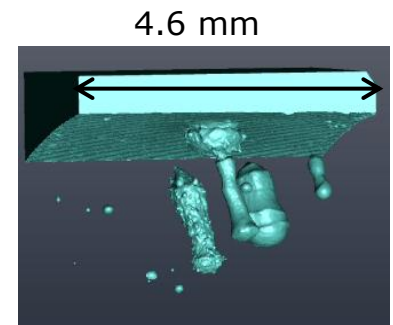
# 3D Imaging of Oxides and Porosities

Oxides  
Porosity

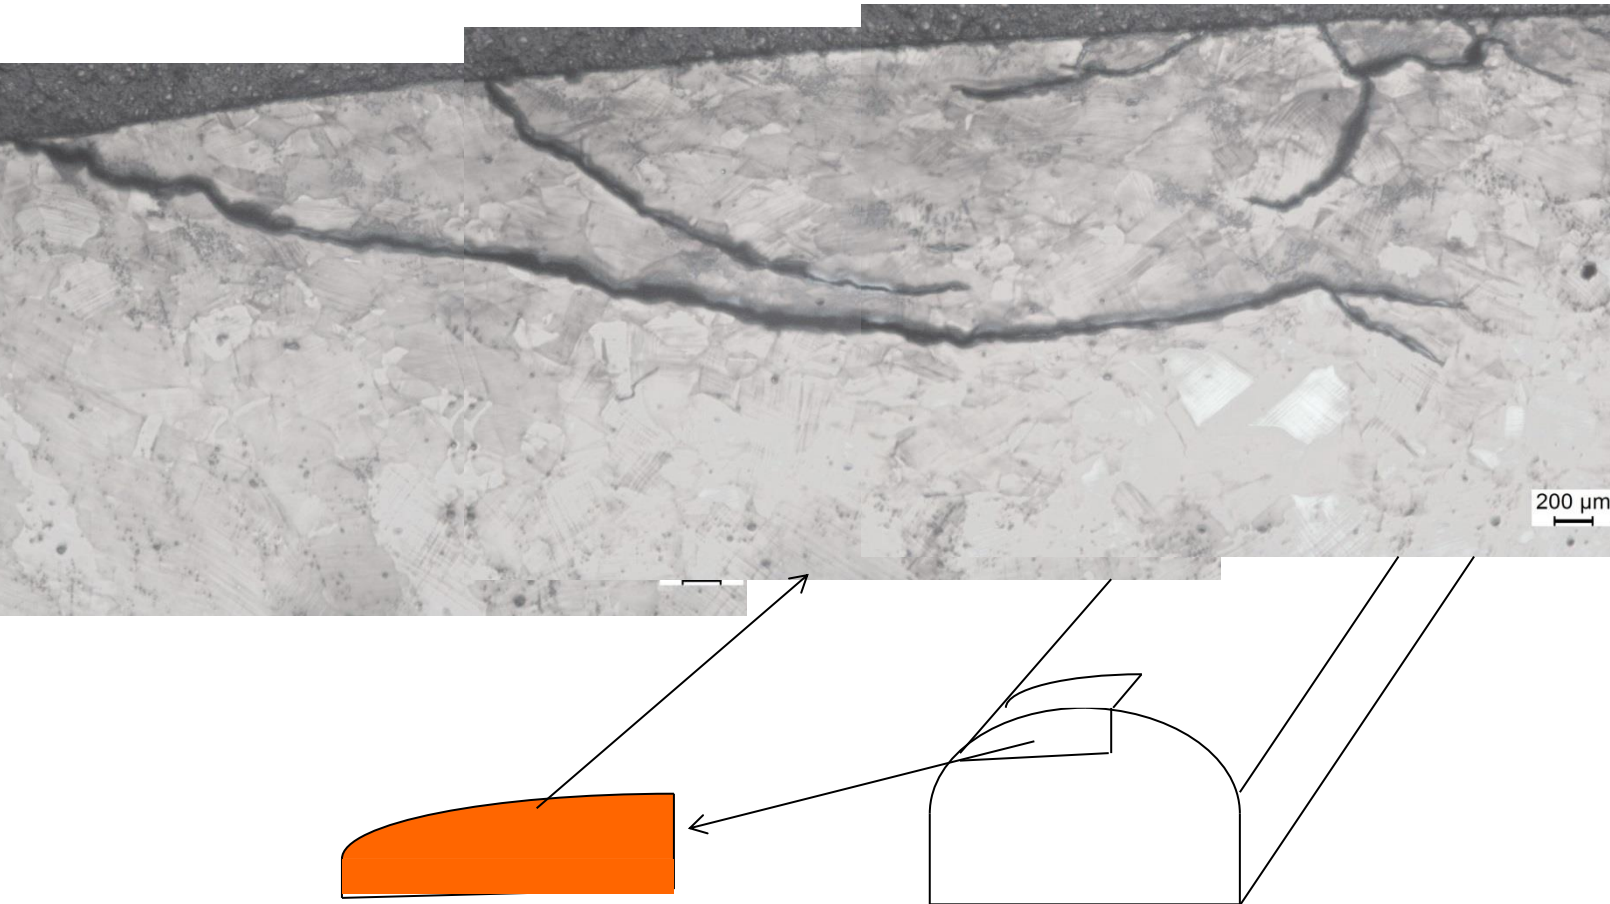
## Cracks in the nose

- Deformation due to rail-wheel contact in Manganese crossing runs as deep as 8-10 mm from the surface.
- Cracks are mostly confined in the plastically deformed layers(first 3 mm )
- Most of the cracks has a definite path. They deviate from their main path after certain depth from the surface and propagate parallel to the running surface.
- The extension of the cracks was found to be as long as 8mm or more.
- High deformation causes changes in profile and hardness. The hardness can be as high as 600 Hv.

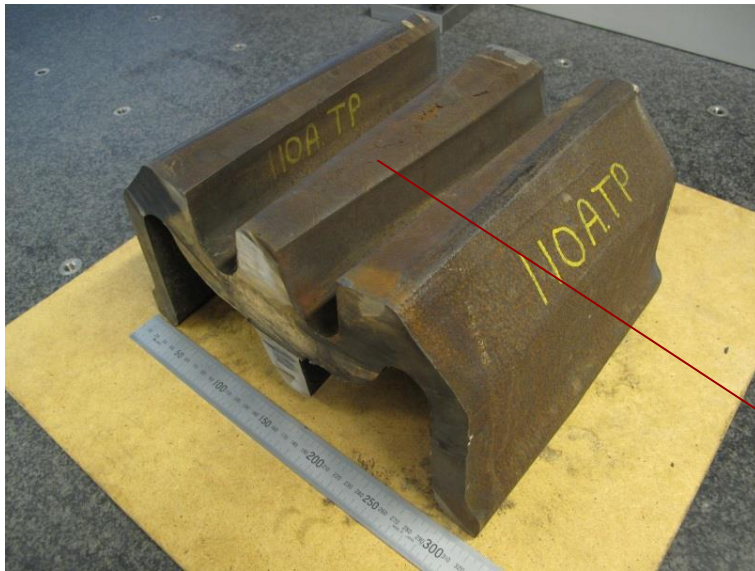
Nearly all traffic goes in the direction from the wing to the nose.

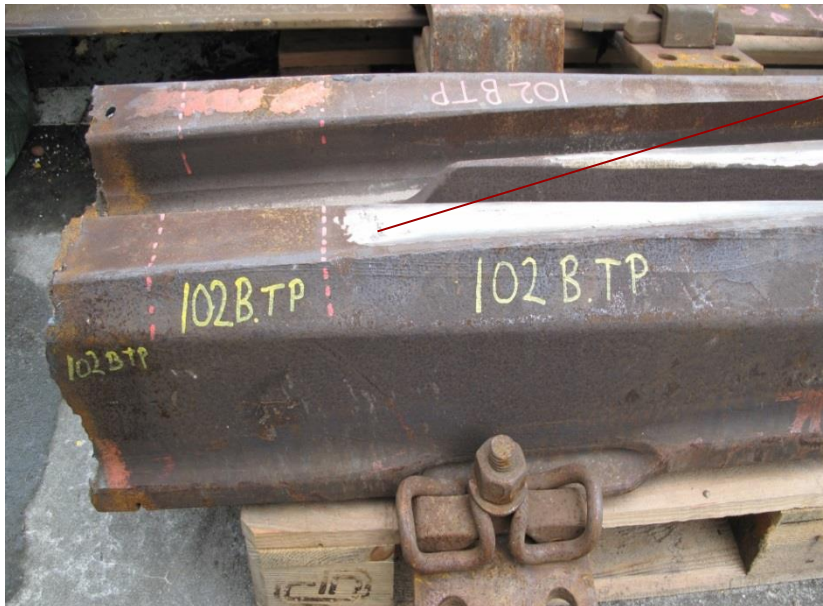
Region of Impact

Chances of crack

Nearly all traffic goes in the direction from the nose to the wing

- However, its not the deformation which causes the crack but rather the impact from the wheel which leads to the crack formation.
