Degradation of rail steel in S&C´s

Carsten Jörn Rasmussen, Banedanmark

Presented at Intelliswitch symposium, August 2017

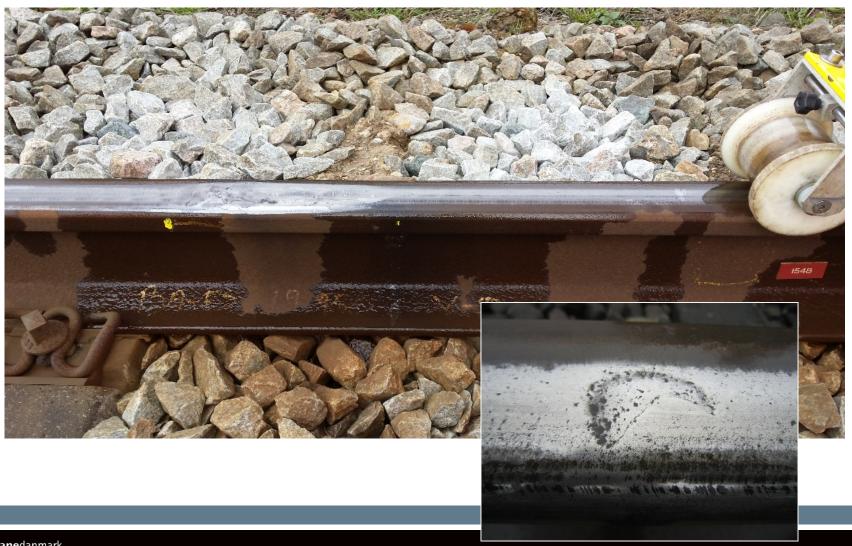
Squats in stock rail

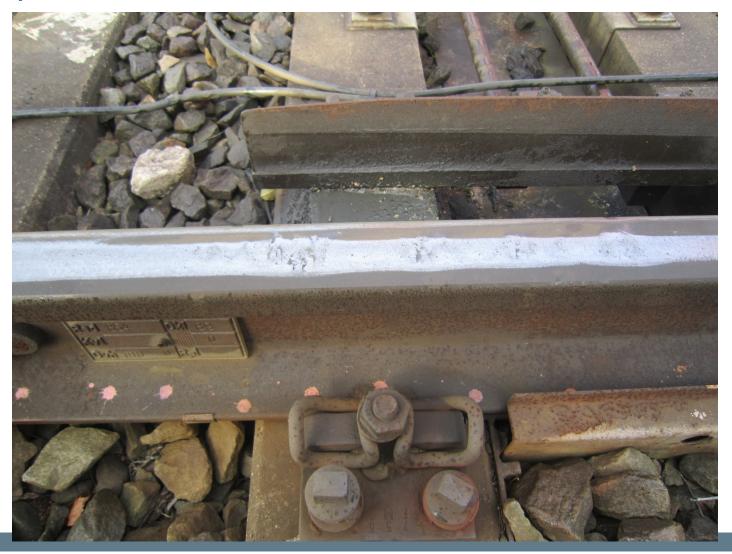
Defect in weld

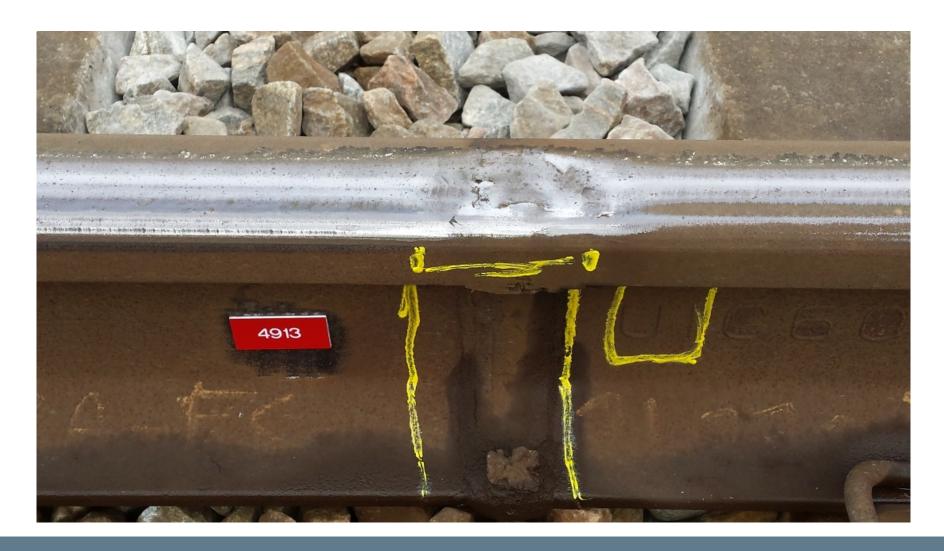
Corrugation

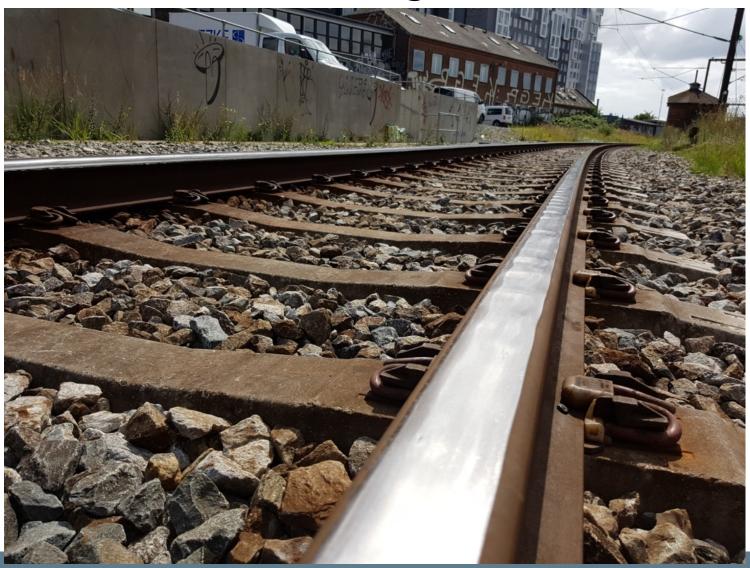
Isolation joint

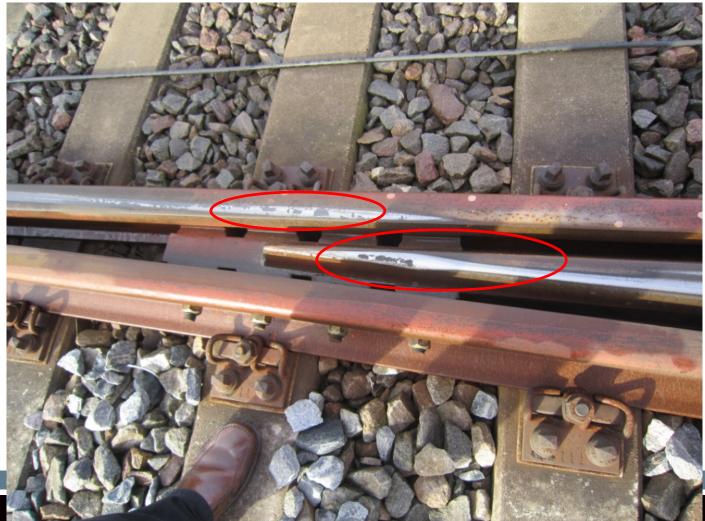
Transition zone nose/wing

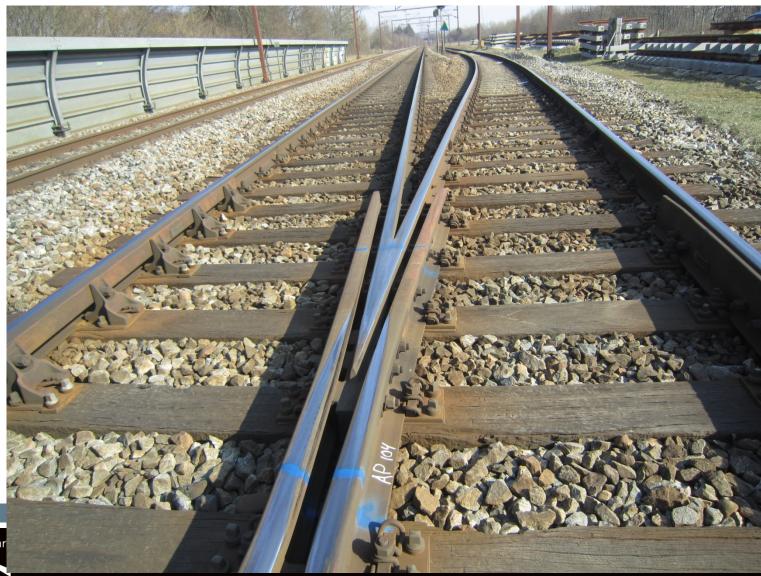
Transition from nose to wing

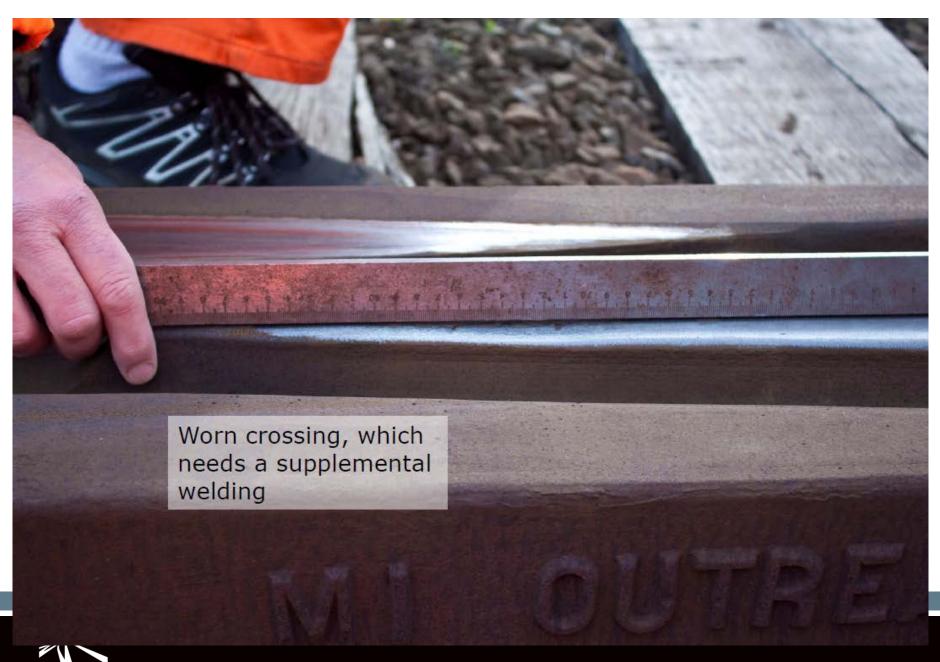
Degradation of nose of crossing

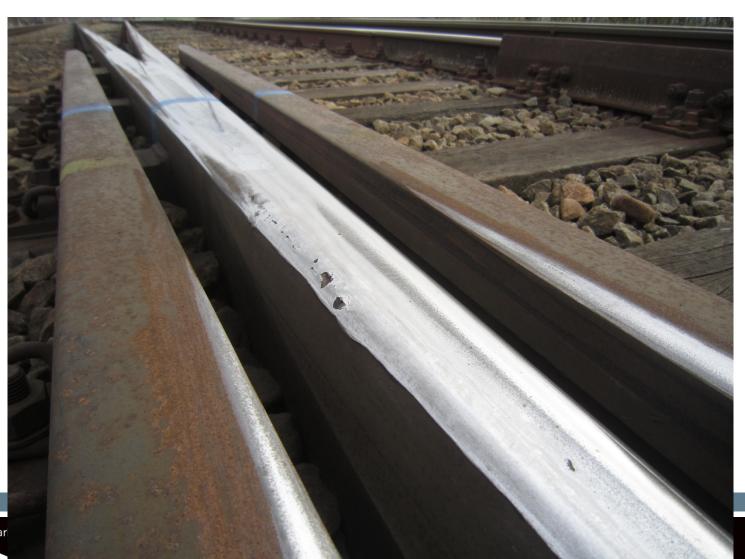
Deformations and cracks in nose of crossing

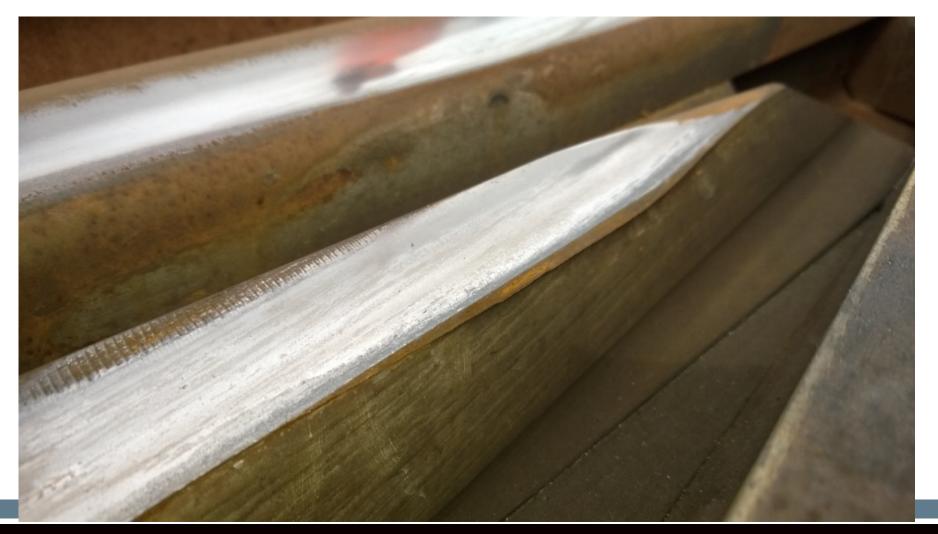
Manual preventive grinding of lipping steel:

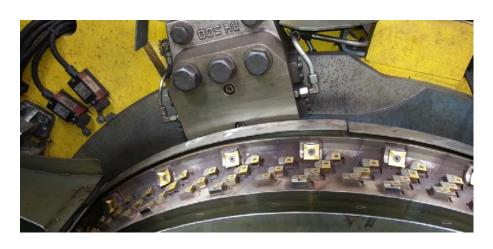
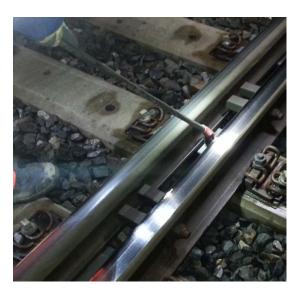
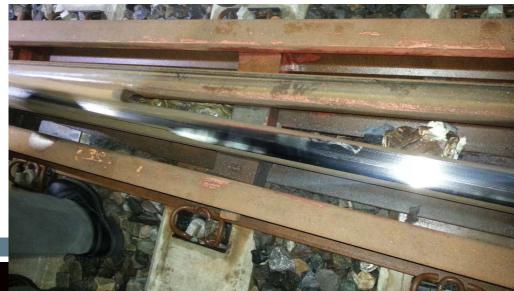
Automatic planning of S&C:

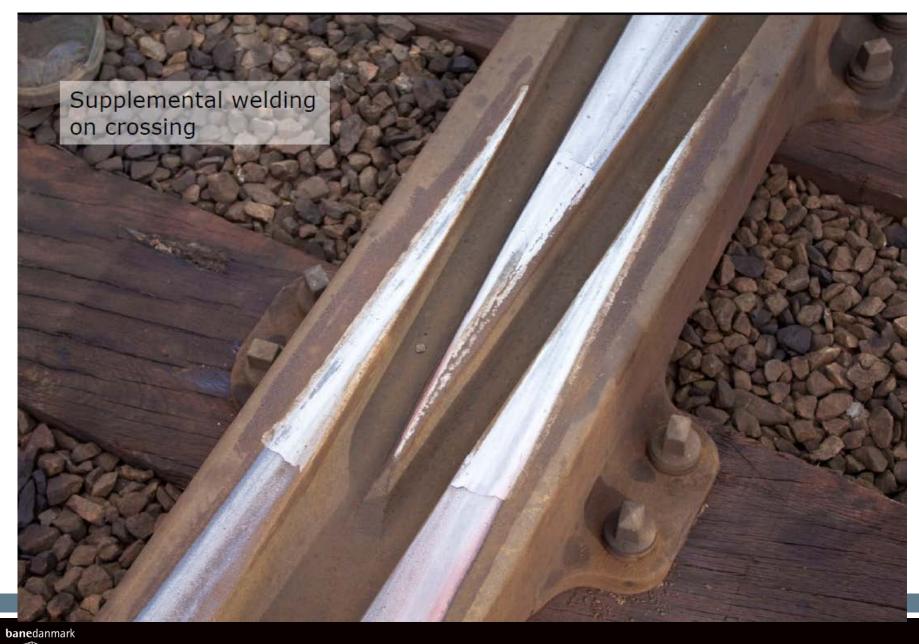
Heavy degradated nose of crossing – to be exchanged!

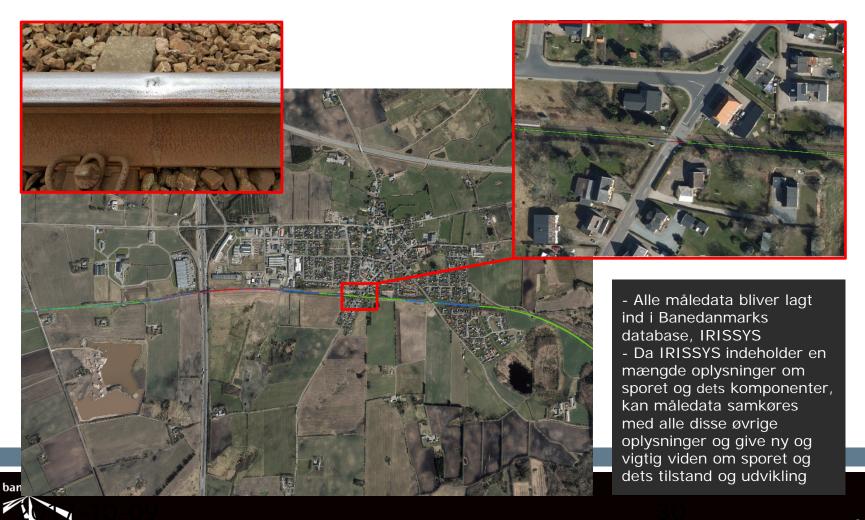
Correlations between degradated steel components (eg. S&C´s) and noise.

Noise measurements in Banedanmark

Correlations between degradated steel components (eg. in S&C´s) and noise.

To detect degradation in an early stage to optimize maintenance activities – e.g. milling.
