New more elastic turnouts in Finland

International Symposium on
Railway Switches and Crossings

Riku Varis

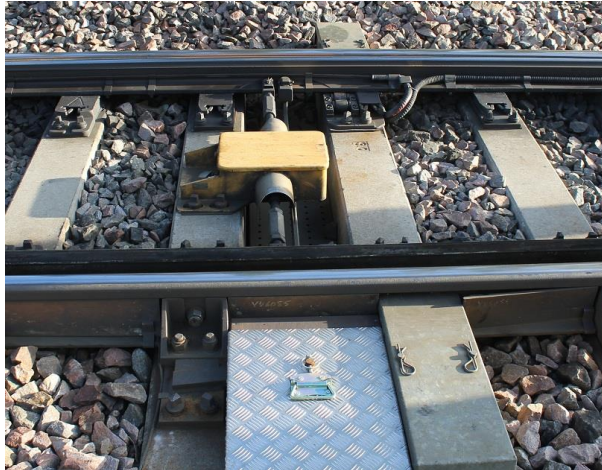
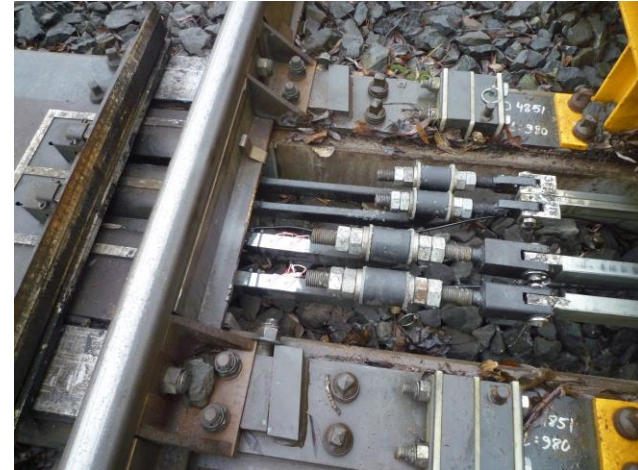
- The driving rods of actuators are positioned in between two sleepers which mean that mechanical tamping in this area is not allowed.
- Sleepers starts to settle over time and dynamic impacts are increasing.
- Low temperature and snow is forcing us to use inner locking system and so on interaction between switch blade and stock rail cannot be controlled.
- To ensure safety in the point machine area, stock rail is fixed to the two bearers without proper elasticity.

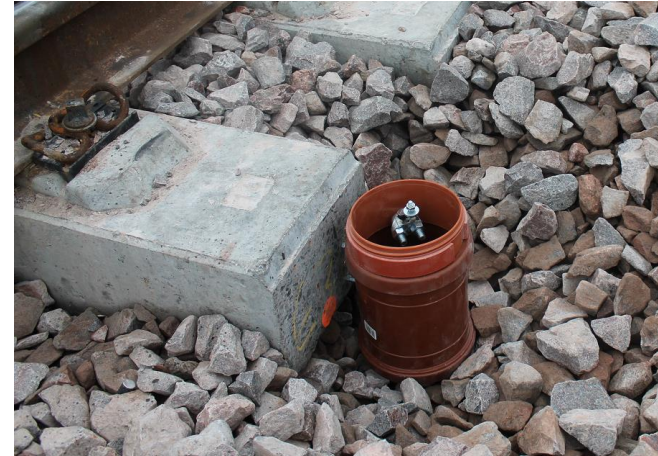
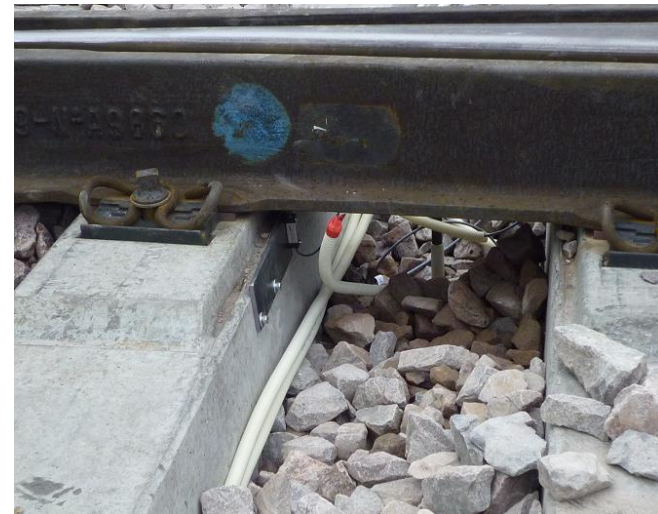
- Three turnouts (1 old and 2 prototypes) with the same measuring equipment
- **Vertical movement of rail compared to bearers**
- **Vertical movement of bearers compared to substructure**
- **Temperature inside the hollow bearers**
- **Axle loads**
- Movement of the actuator rods (Kouvola)
- Force of the actuator rods (Kouvola)
- All of these are measurements done in some defined points, but together with these also continuous measurements of track geometry and deflection was made (Stiffmaster and RAMI-wagon).

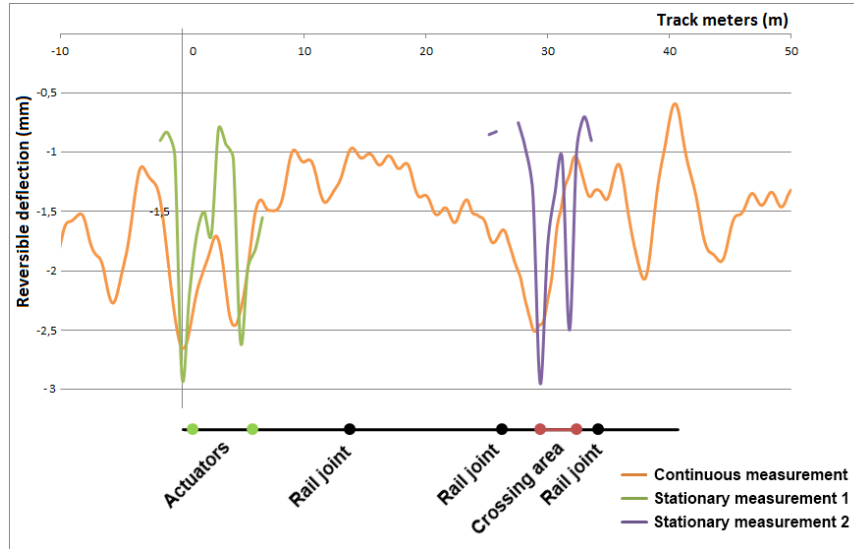
Taavetti V413 (3 years after installation)

- Examples of reversible deflection during train passage..

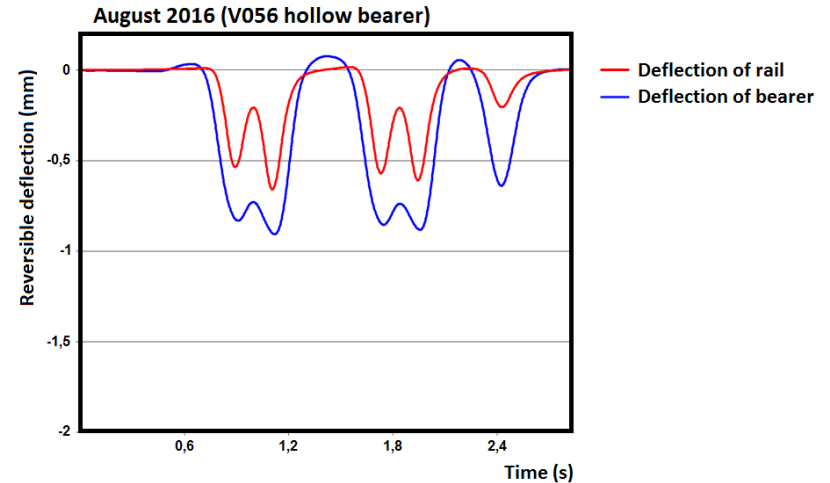
- Same sensors also enables the monitoring of long period settlement and changes in deflections
- Results shows that the deflection has only minor changes ($< 0,5$ mm) during the test period.
- Test period is still quite short so major conclusions about the future are hard to make
