# Impact fatigue in several low alloy steel grades used in railway switches

Strain partitioning and damage in carbide free bainitic steels using  $\mu$  DIC.

SYM INTELLISWITCH, Copenhagen, Denmark (29-08-2017)

Project F91.5.12475b, Department of materials science and engineering, Delft university of technology.

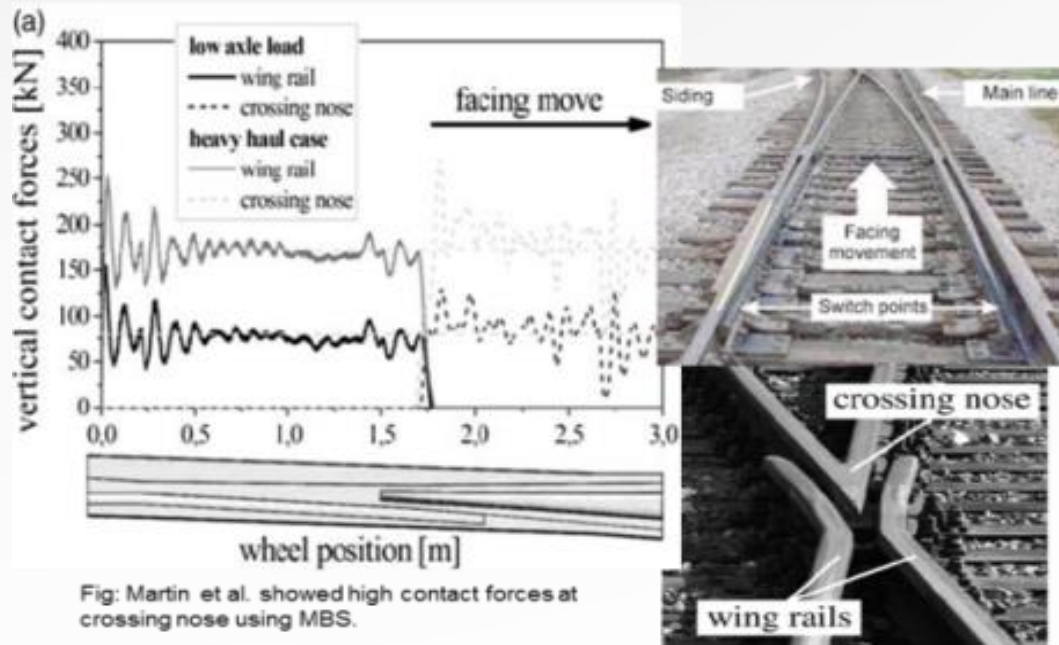
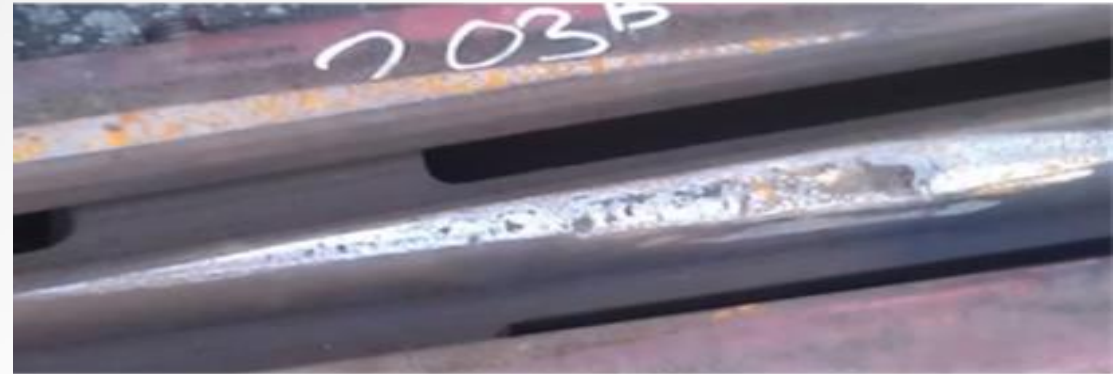
## Loading conditions

- 1. High dynamic loading due to Irregularity/Gap.
- 2. Sliding and Impact occurs during transition of wheel.
- 3. Irregular wear, accumulated plastic deformation, Cracking, Head checks, Squats and partial brittle fracture.

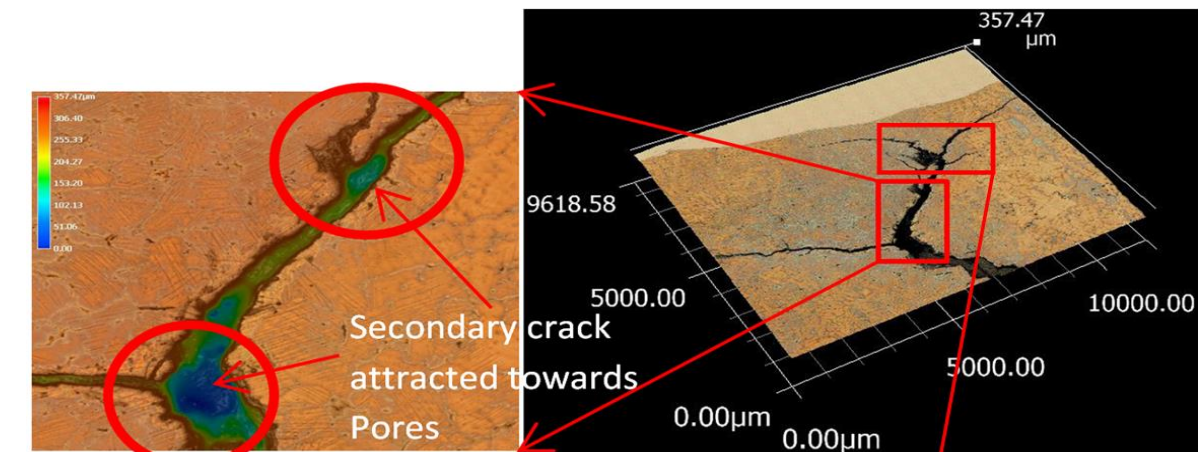
# Cast Headfield Steels-

Casting defects like porosity and inclusions as a cause of failure.  
Study of failure in relation with deformation twinning.

Nano twinning with a spacing ranging from 5 – 10 nm formed close to the crossing surface. Crack growth is restricted when it propagates perpendicular to twin orientation whereas assisted when it grows along the twins. Cracks are being attracted towards the pores/casting defects.
